The Hopkins Ultraviolet Telescope

Engineering Report for the Astro-2 Mission

September 1995

**The Johns Hopkins University
Center for Astrophysical Sciences**

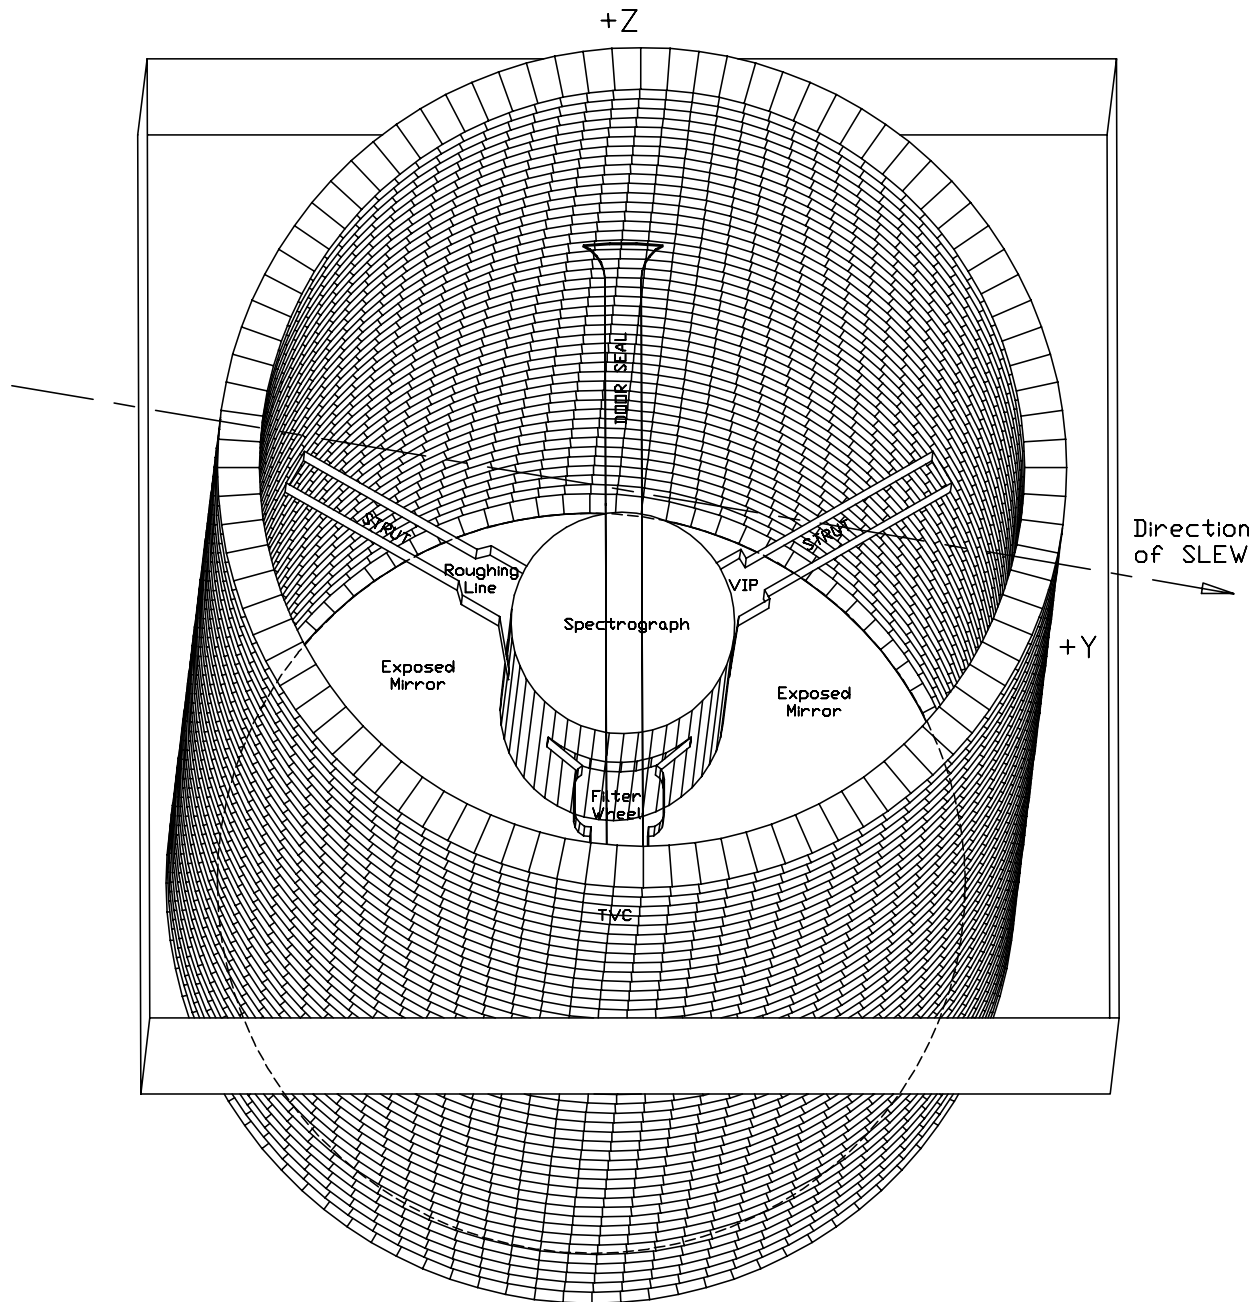
Figure 5-1

At MET 6/11:15, the 20° minimum ram constraint of HUT was violated during a setup. The doors were mistakenly opened seven minutes early and were fully open at a ram angle of 8.6°. This angle increased linearly with time until a safe angle of 22° was reached five minutes later. Approximately 40% of the +Z portion of the mirror was exposed during the violation, with a peak value of 16% as shown in figure 5-1.

This constraint violation occurred due to an error in the sequence load. The doors were closed prior to the QUIT on the previous target as required. The sequence load for the next target, (M49), should have included a closed door state but had a door state of '5' (both open) instead. This

The ram constraint is derived from the 16° angle (plus margin), before the edge of the HUT primary mirror is exposed. Silicon carbide is degraded by direct exposure to atomic oxygen. Analysis up to this point does not indicate any noticeable degradation. The plot on the following page shows the point of maximum mirror exposure and the direction of SLEW. This indicates that approximately the top 40% of the mirror was directly exposed to the ram during the SLEW. The total duration of the exposure lasted six minutes, although the maximum exposure to any part of the mirror did not exceed two minutes.

Since the direction of SLEW only exposed the +Z portion of the mirror, it would be difficult to determine if a small degradation of the silicon carbide coating took place. Only a full aperture calibration before and after the incident would be able to show the degradation. There has been no noticeable drop in efficiency noted to this point.

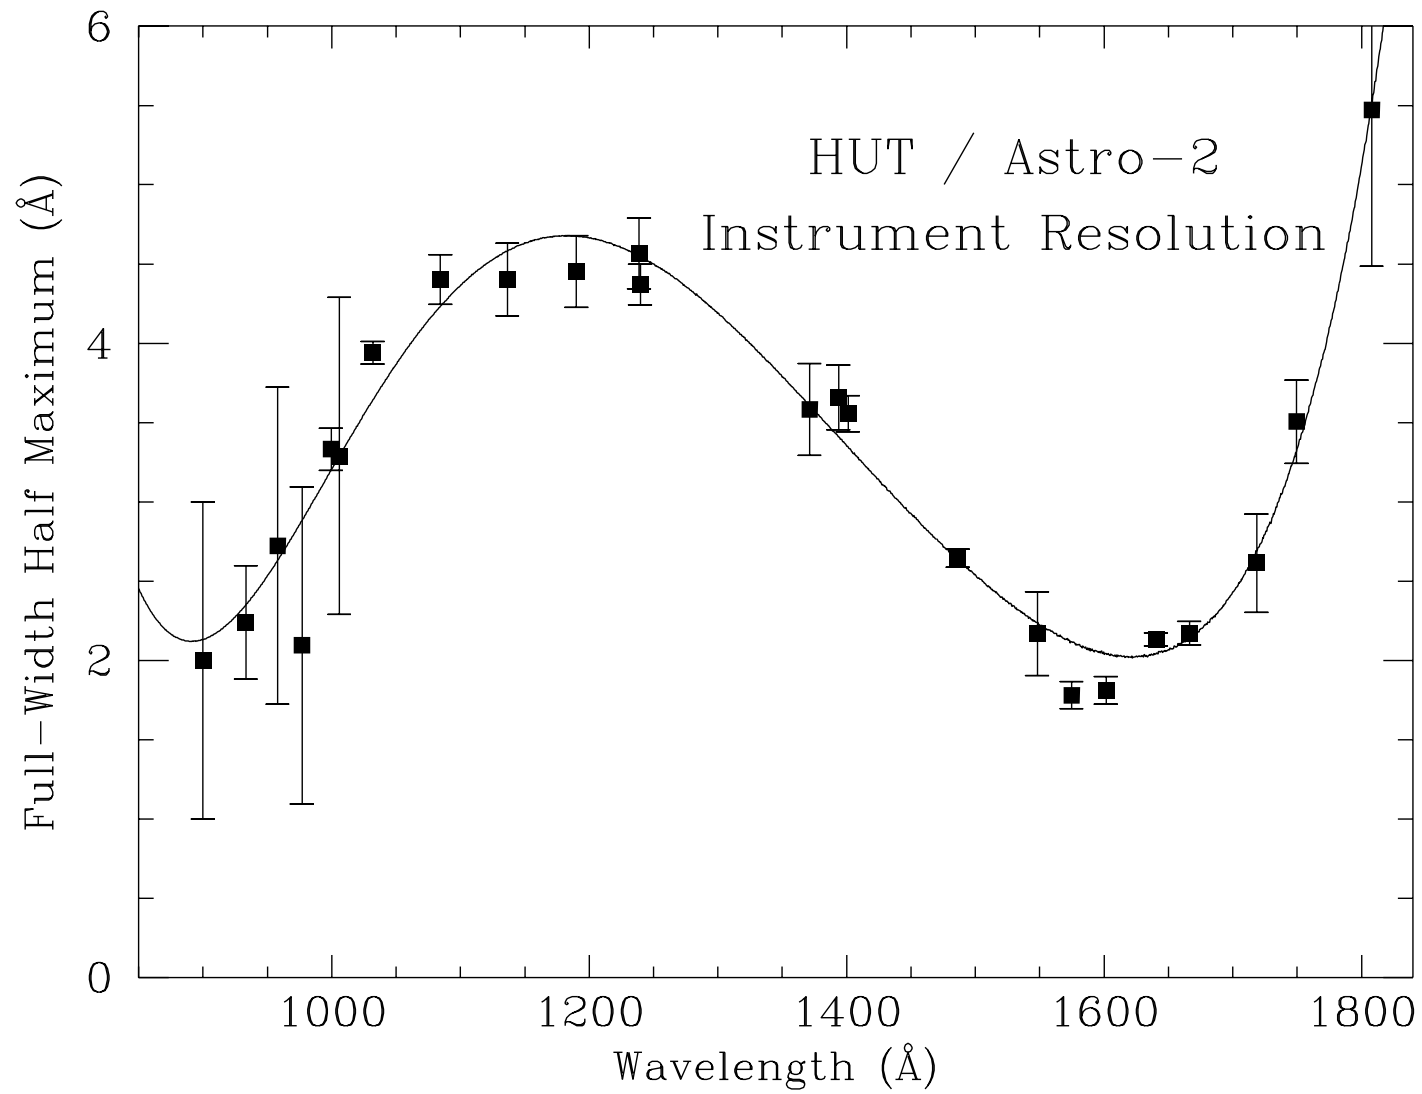
**Figure 7-2**

Due to alignment differences between the spectrograph and television camera, it was not possible to focus both simultaneously. Ideally, the best spectrograph focus position would be used during the flight but the 380 μm difference in focus between the two was large enough to force the use of a compromise mirror position about 100 μm from the optimum spectrograph focus. The worst focus was at 1250 Å, where the spectral resolution was limited to 4.5 Å. The points of best focus were at 900 Å and 1600 Å, where the resolution was 2 Å. These positions are shifted slightly from the desired locations of 1050 Å and 1350 Å. This shift can probably be attributed to the compromise mirror position used. A plot of the spectral resolution versus wavelength appears in figure 7-2.
