## **The Hopkins Ultraviolet Telescope**

# Engineering Report for the Astro-2 Mission

September 1995

The Johns Hopkins University Center for Astrophysical Sciences

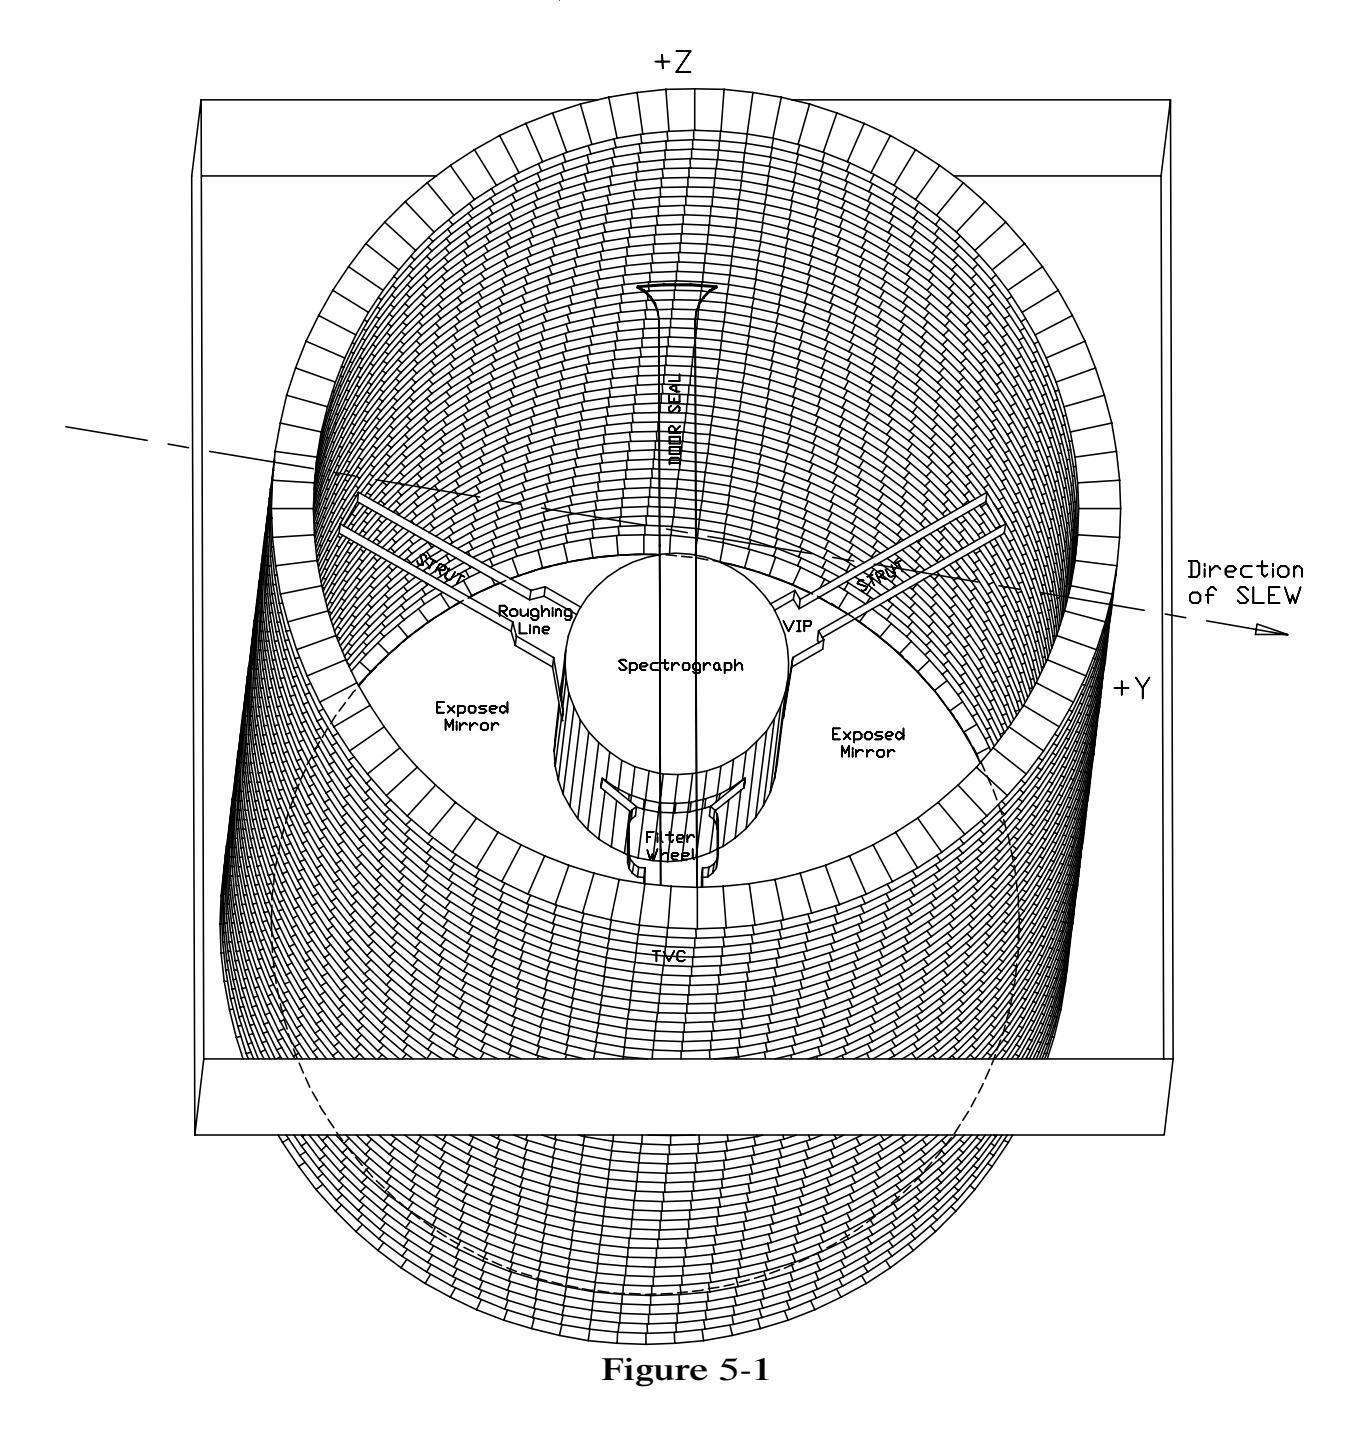
Maximum Mirror Exposure at GMT 067/17:55:09

At MET 6/11:15, the 20° minimum ram constraint of HUT was violated during a setup. The doors were mistakenly opened seven minutes early and were fully open at a ram angle of 8.6°. This angle increased linearly with time until a safe angle of 22° was reached five minutes later. Approximately 40% of the +Z portion of the mirror was exposed during the violation, with a peak value of 16% as shown in figure 5-1.

T nstraint violation occurred due to an error in the sequence load. The doors were closed prior to the QUIT on the previous target as required. The sequence load for the next target, (M49), should have included a closed door state but had a door state of '5' (both open) instead. This

The ram constraint is derived from the 16° angle (plus margin), before the edge of the HUT primary mirror is exposed. Silicon carbide is degraded by direct exposure to atomic oxygen. Analysis u this point does not indicate any noticeable degradation. The plot on the following page shows the point of maximum mirror exposure and the direction of SLEW. This indicates that approximately the top 40% of the mirror was directly exposed to the ram during the SLEW. The total duration of the exposure lasted six minutes, although the maximum exposure to any part of the mirror did not exceed two minutes.

Since the direction of SLEW only exposed the +Z portion of the mirror, it would be difficult to determine if a small degradation of the silicon carbide coating took place. Only a full aperturecalibration before and after the incident would be able to show the degradation. There has been no noticeable drop in efficiency noted to this point.

opened the doors when the SETUP command was given. For future observations, all RAM test procedures were flagged to check for the proper door state.
