The Hopkins Ultraviolet Telescope

Engineering Report for the Astro-2 Mission

September 1995

**The Johns Hopkins University
Center for Astrophysical Sciences**

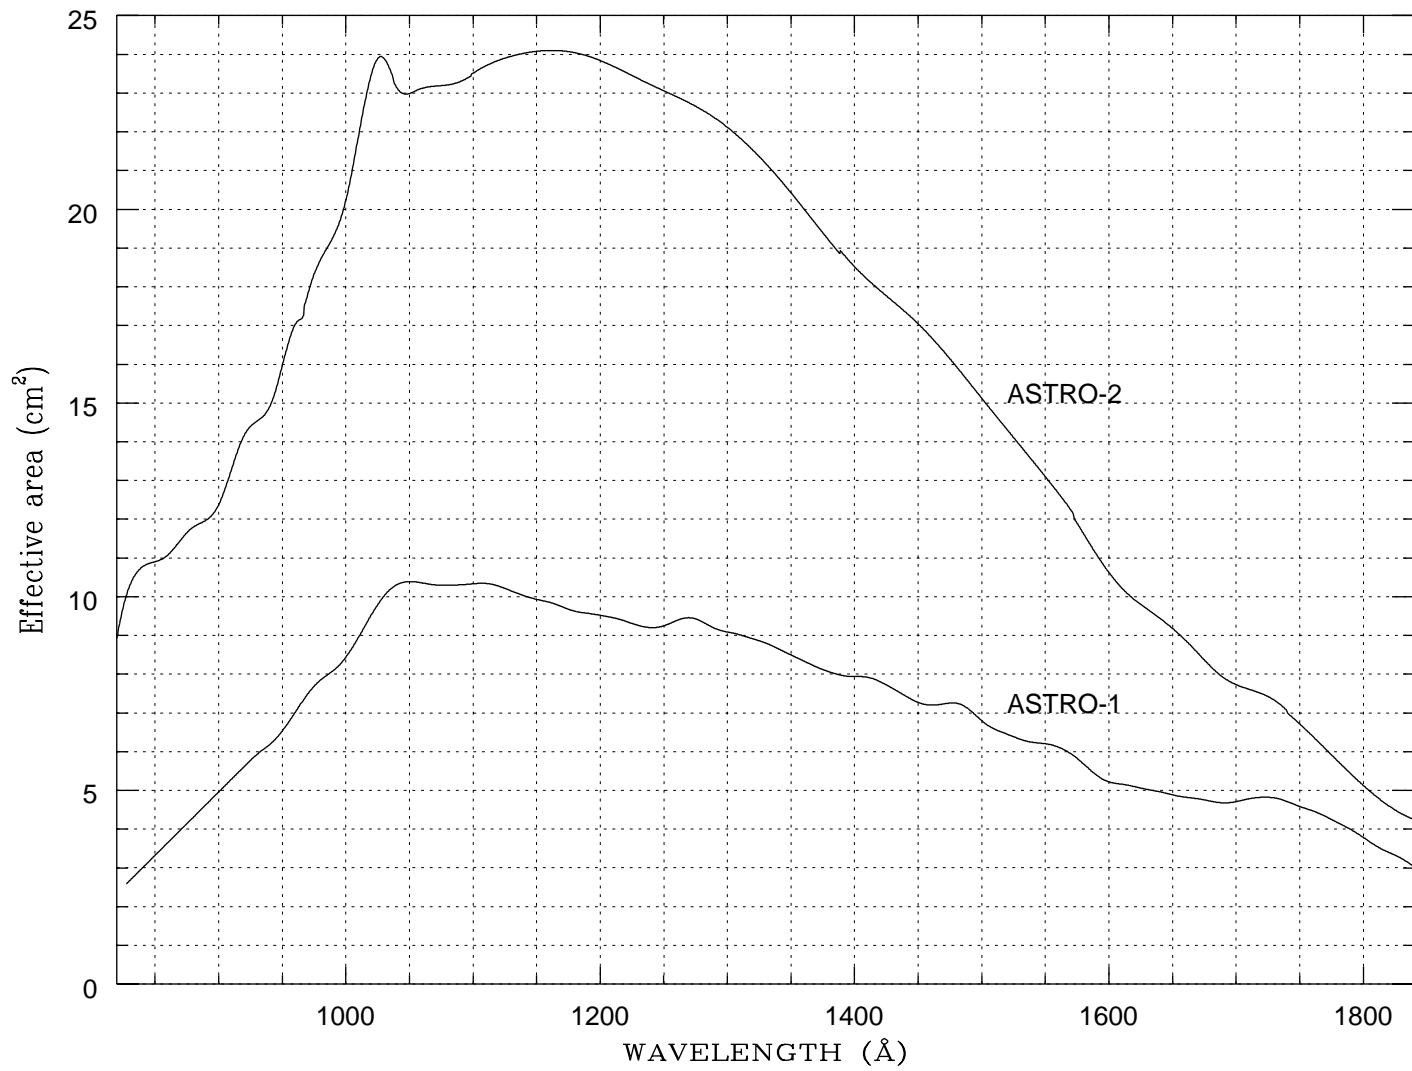
**Figure 3-1**

The net effect of the new coatings on the grating and primary mirror can be seen in figure 3-1 at the end of this section. The effective area was increased by more than a factor of two for all wavelengths shorter than 1600 Å.

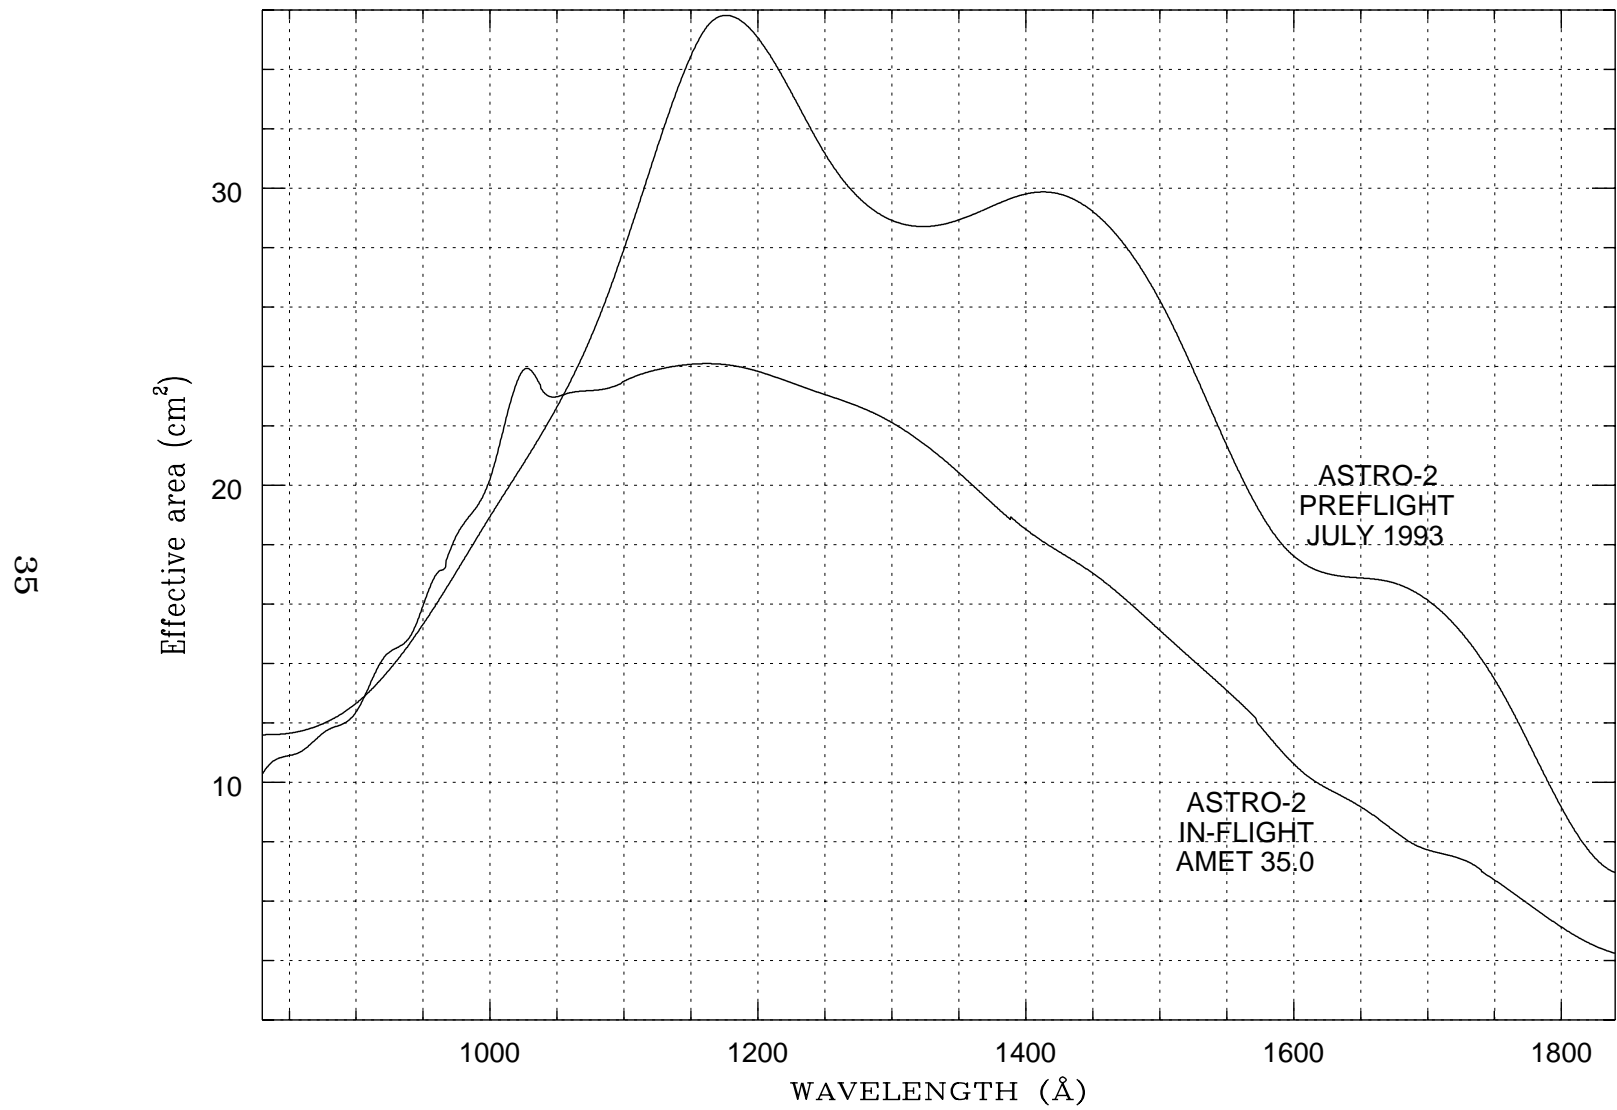
Figure 7-1

The ground calibration of the instrument's sensitivity differed as much as 45% from the calibration obtained in flight. This is shown in figure 7-1, and discussed in detail in §7.2. A decline of at least 30% was expected due to the aging of the detector's photocathode.
